# TransCanada's Keystone XL Southern Segment:

## Construction Problems Raise Questions About the Integrity of the Pipeline

November 2013

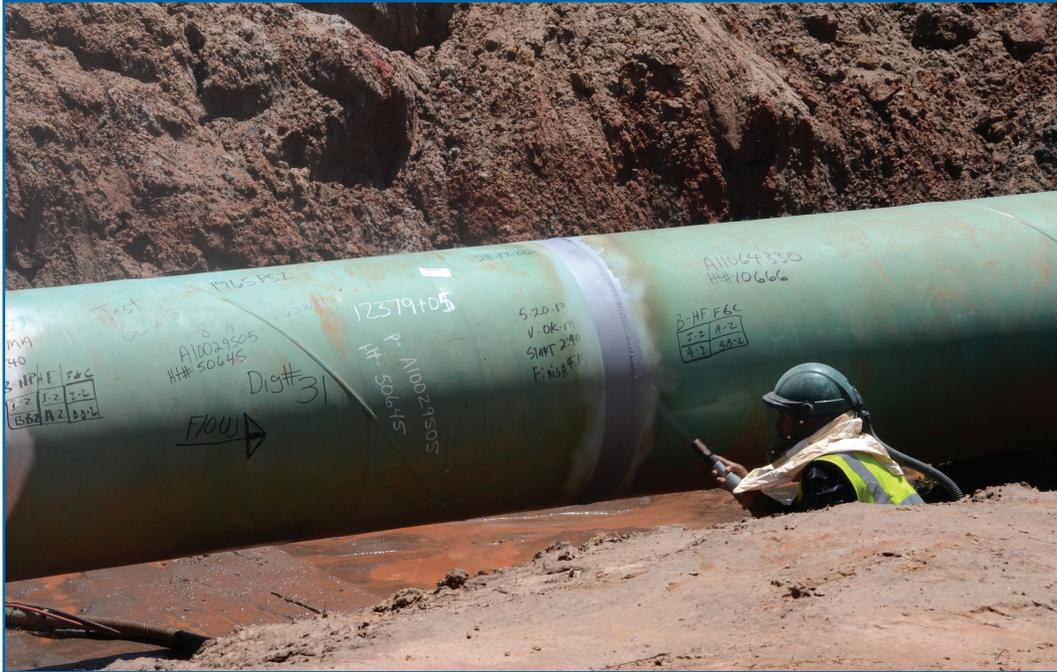
Workers in a trench are finishing the new replacement of pipe on a landowner's property.

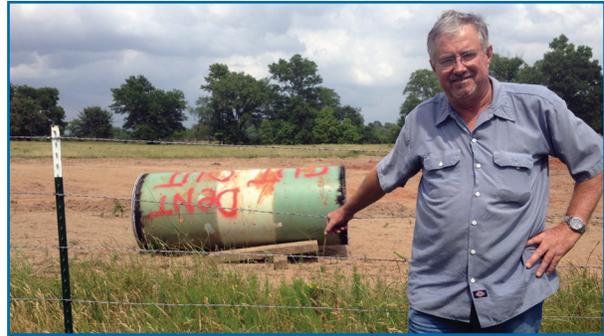
One day in mid-May, Whitley saw a section of excavated pipe marked with the words "Dent cut out" on the ground next to a trench where pipe was being replaced.<sup>30</sup> Whitley observed the pipe replacement process, including the partial removal of a large rock that had been left in the original ditch. As Whitley and witnesses observed the new replacement pipe being welded into place, an inspector remarked that there were dozens of anomalies.<sup>31</sup>

*David Whitley stands near his fence with a short piece of removed pipe marked "Dent" and "Cut Out."*

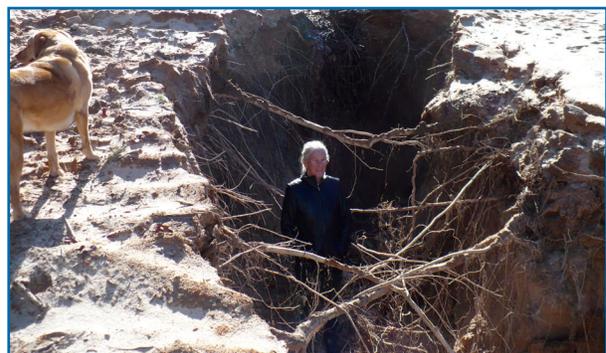
Eleanor Fairchild, 78, owns a 350-acre farm south of Winnsboro, Texas. She has complained of severe erosion resulting from the construction of the pipeline and is pictured below near a hillside that is adjacent to her property's wetland. With Fairchild's property, it is not clear whether the appropriate construction mechanisms have been implemented, because a deep crater had formed where none existed before. Despite more than eight months of asking TransCanada to remedy the situation, the erosion has not been successfully addressed, and the agency that oversees the construction has been unwilling to help her.<sup>33</sup>

*Eleanor Fairchild stands in an erosion area adjacent to a wetland after pipeline construction on her property.*

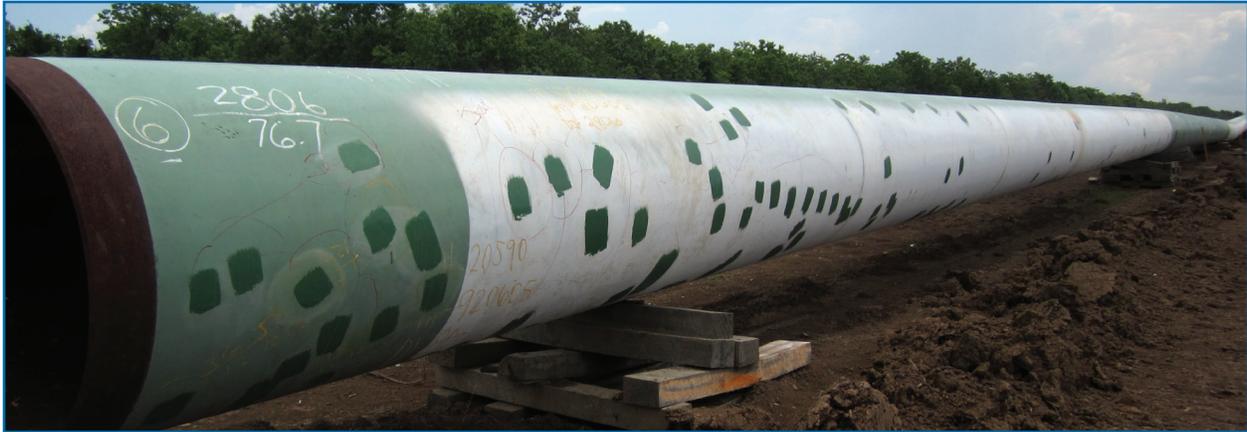
*Dark green areas show extensive applications of field coating, or patching, over damaged areas on the pipe before it is lowered into the trench during pipeline construction. The code required reasonable care in handling of the pipe to avoid damage to this very tough coating.*

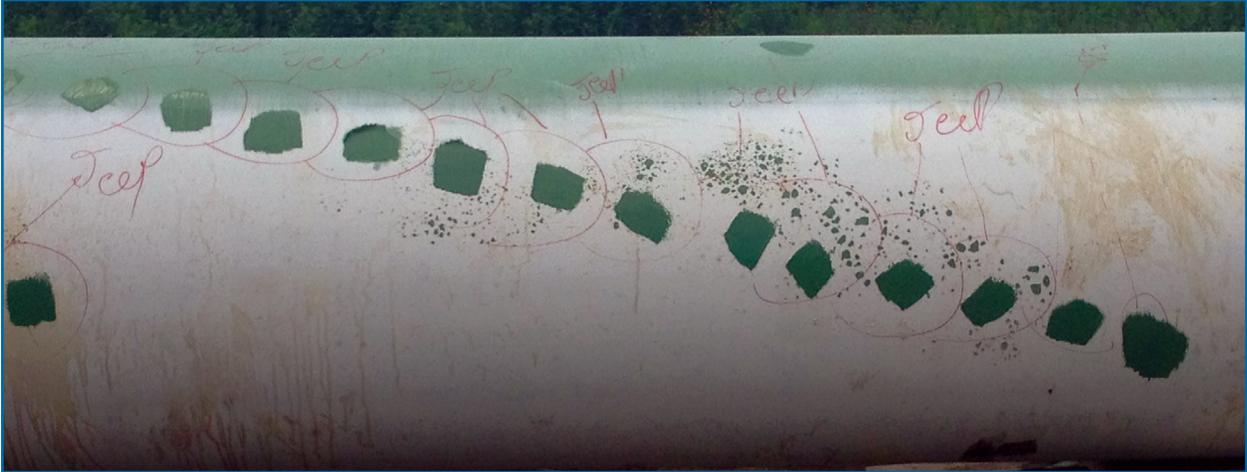
*Patches have been applied to cover “holidays,” or holes and pipeline damage. Some of the patches are peeling before the pipeline is to be buried in the ground.*

The dark green patches, as illustrated in several of the photos in this report, are repair patches covering exterior damage that occurred during handling of the pipe in construction. This patching, or field coating, has been applied over a white paint used as a kind of sunscreen protection during the long pipe storage period. The light green area is the original powder coating bonded on the pipe during the manufacturing process.

Holes or damage to the original coating to the extent shown above indicates rough handling of the pipe. The damage, called “holidays” by the industry, can be points of discontinuity (such as holes and scrapes) where the pipeline surface is exposed to the environment, which can promote corrosion of the pipeline.<sup>37</sup>

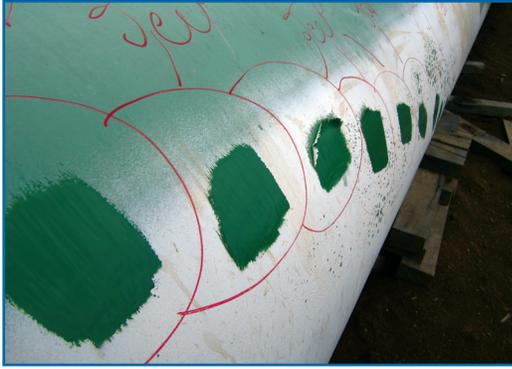
*Close-up pictures of the repair patches, showing that the apparent lack of surface preparation before application of patching material has resulted in repair patches not adhering to the pipe. Pictured above some of the patches in this photo is the word "Jeep." A jeep is an electric tool used to detect pipeline abnormalities or holes.*

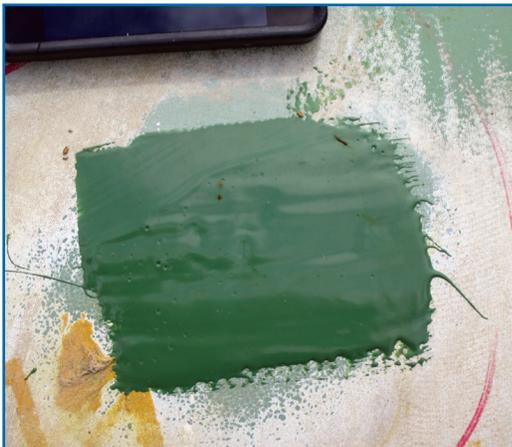
*Tiny holes in the patching indicate uneven application of field coating, which can partially expose the area that had been repaired.*

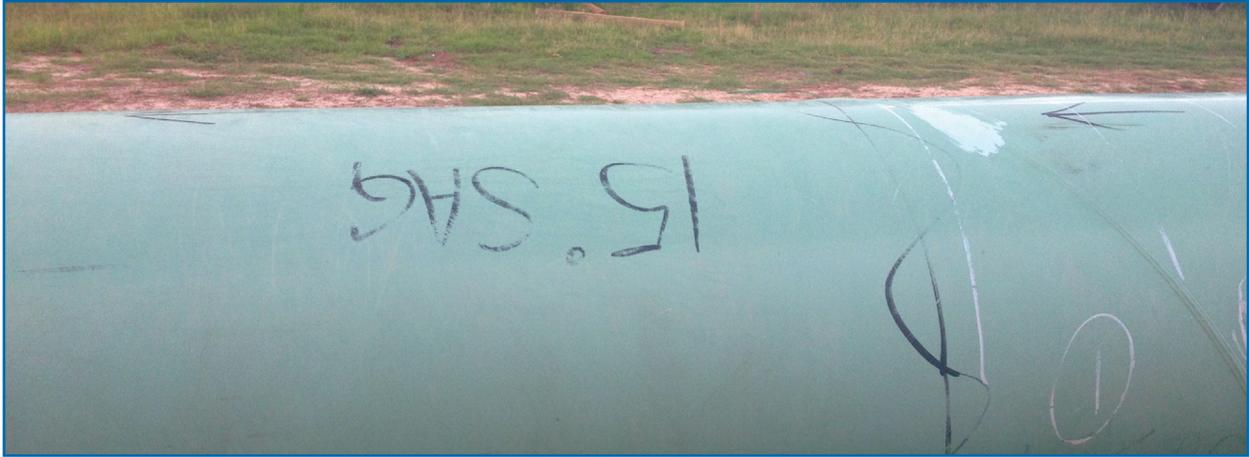
East Texas residents discovered sags in various locations where pipe had been excavated.<sup>44</sup> Unintentional sags due to pipe unsupported during lowering into a trench, or while pipe sections are welded together, can result in permanent bends and can allow buckling to occur. This ultimately can lead to cracks and ruptures. The degree of sag was indicated on the excavated sections. In this case, the sag of the pictured section above was 15 degrees, and the section was removed from the trench.

*A pipeline section that is cut out evidently due to the excessive sag or bending of the pipe.*

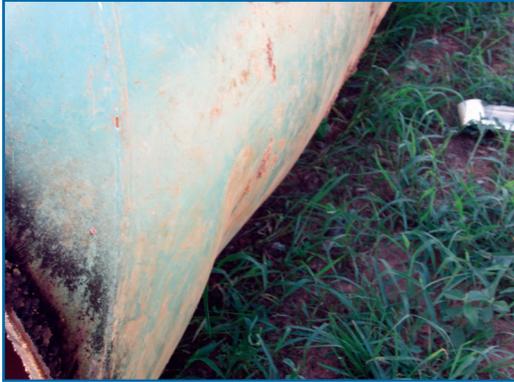
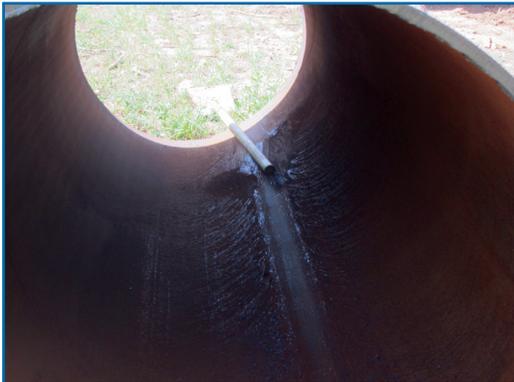
*The two shots are of the exterior and interior of a massive dent from the inside of a pipe section near Jacksonville, Texas.*

Dents were among the anomalies identified in new pipe excavated along the pipeline route. The code currently allows only for nominal mechanical deformation.<sup>45</sup> Some dents that were observed were as deep as that of a brick. Dents most often occur when pipe is placed in a trench where rocks or debris are present.<sup>46</sup> The code of construction requires pipe to be laid flat on the bottom of the trench and firmly supported. Once the trench is ready to be backfilled with soil to close the ditch, any remaining debris underlying the pipe can dent the pipe due to the downward weight and pressure of the compacted soil and backfilling equipment.<sup>47</sup>

Dents can provide major areas of stress concentration on a pipeline, since cracks will often develop over time where the creases of dents occur, fostering the probability of a leak or rupture where those stress points are located on the pipe, especially if dents occur on welds.<sup>48</sup> It is a qualified inspector's responsibility to ensure that the construction contractor does not lay or cover pipe in a ditch until the ditch can provide smooth, firm underlying support for the pipeline, as mandated by the quality assurance requirements of the construction code.<sup>49</sup> Fuel Fix photos published in late October, along with photos from the Houston Chronicle, indicate that the ditching inspector did not ensure that rocks were removed from the trench before lowering the pipe into the ditch.<sup>50</sup> Aerial pictures of an active excavation site showed that rocks were removed from under a portion of the pipeline that was excavated.

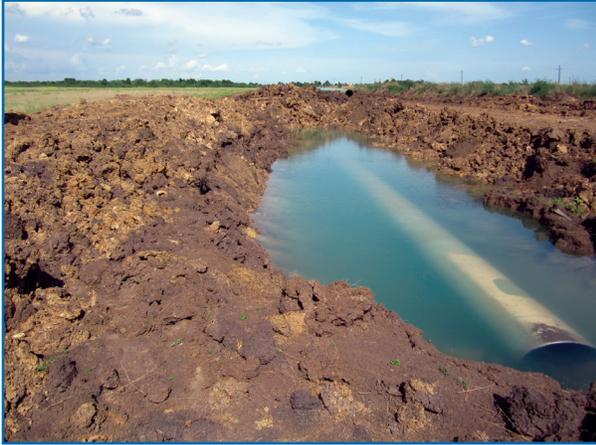
*The pipe is not level in the ditch. The trench has collapsed around it on a construction site near Beaumont.*

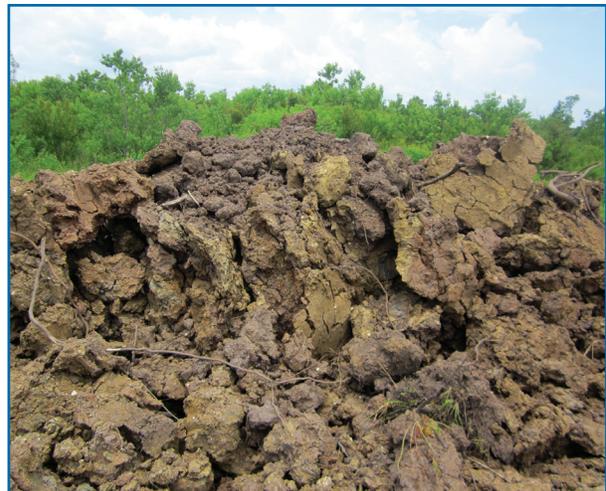
The code of construction requires good right-of-way reclamation practices for ground disturbed during construction.<sup>55</sup> Good construction practice requires that excavated topsoil be kept separate from the subsurface materials, so that when the pipe is finally covered up, the arable topsoil can be once again placed atop the ground's surface to ensure plant and crop growth.<sup>56</sup> On David Holland's property, and on other properties, the darker topsoil appears to have been comingled with the lighter sterile subsurface clays. If the arable and substrate soil shown in this picture is used in this mixed form to cover the trench, the farmer or landowner will have difficulties growing crops, pasture or other plant life in the same way as before the ground was disturbed. David Whitley has complained that the soil where the pipeline had been constructed will not grow grass as expected for grazing purposes. Instead, only plants of no agricultural value can grow there. Many other landowners have reported a similar problem.

*The good black topsoil and the underlying yellow substrate are comingled on this landowner's property near Beaumont. When replaced over the trench, this mix will not support valued agricultural plant life.*

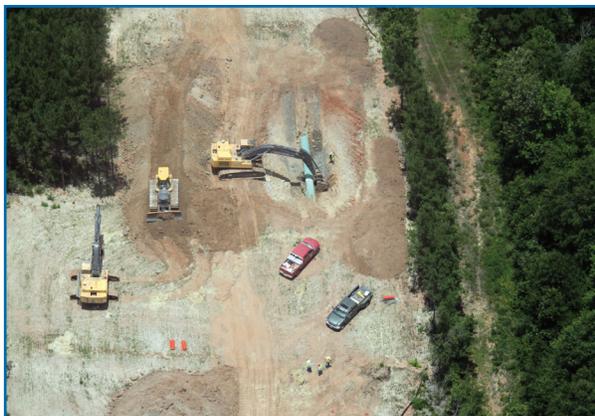
*In filling the trench on this construction site near Lufkin, the trackhoe's bucket is pulling soil near the pipe, affording the possibility for the bucket to hit the line.*

The code of construction has identified improper backfilling as a source of serious pipe damage. Proper filling and compaction of the soil protects the pipeline. Ground disturbance loosens the soil, which must then be recompacted below and around the pipe to re-establish the pipeline's load-bearing capacity.<sup>57</sup>

Improper filling and compaction coupled with subsequent agriculture work, can strain welded areas and can cause pipe damage, especially when there is no internal pressure in the pipe during construction activities, which exacerbates the problem.<sup>58</sup>

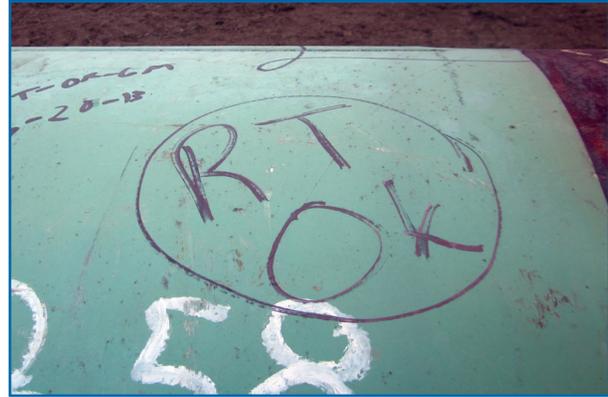
Multiple examples of pipe replaced on the southern segment of the Keystone XL were observed to be marked with “RT,” indicating that Radiography Testing had been used to inspect the welds on the new segments of replaced pipe instead of utilizing the more precise Automated Ultrasonic Testing (AUT).<sup>62</sup> AUT uses sound waves at high frequency.<sup>63</sup> With AUT, an array of probes are mounted outside the pipe. The probes move around the pipe to the side of the weld and can pinpoint the exact position of a weld problem as they travel around the circumference of the pipe. Every weld inspected with AUT is inspected to the same level of quality. It is extremely rare to miss fine cracks with AUT technology.

The markings in the picture, and observed frequently in the field, indicate that RT was used to inspect the two new welds per each replaced pipeline section. RT is a less accurate technology. It is a process similar to taking a medical X-ray.<sup>64</sup> Once the welded pipe is in the ground, external examination is required so an X-ray is then taken from outside the pipe. With this process, the source used for the X-ray will expose both the top and bottom layers of pipe, and thus the weld can be twice the distance from the film, which significantly reduces radiographic quality. The radiography examiner will try to make a judgment on the safety of the welds based on this X-ray, which loses some clarity since it

*Proof that radiography testing (RT) was used during construction. This notation was seen on pipe on multiple East Texas properties.*

is taken through multiple layers of steel. Radiographic technicians prefer to avoid taking these exposures because the results can be quite hard to interpret and cracks are missed.

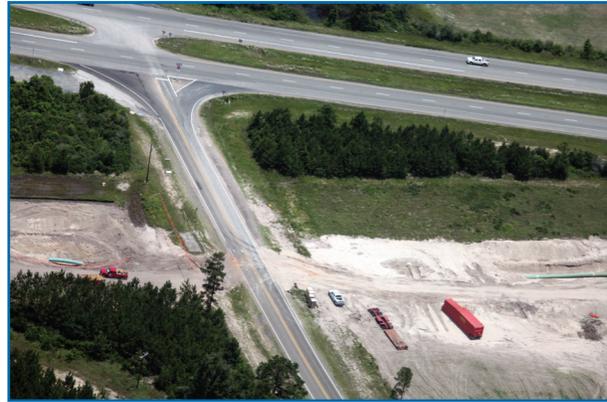
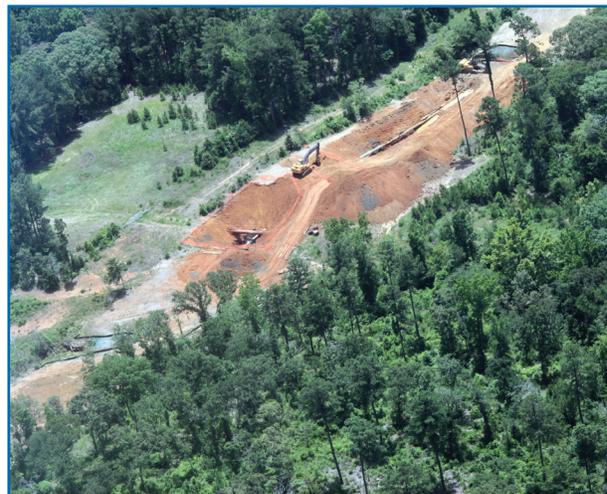
Previous PHMSA advisories have warned companies like TransCanada about welding or tying in the connections between heavy wall and light wall pipe when transitioning construction in areas such as slopes, railroad crossings and sensitive areas where excessive downward pressure can cause the pipe to buckle, collapse, burst or affect the ovality or roundness of the pipe.<sup>70</sup> Special welding techniques are required to weld two different thicknesses of pipe successfully.<sup>71</sup>

*Top: Typical view of a remediation showing extensive pipe exposed near the city of Corrigan. Above: Area near Jacksonville showing a transition area at the bottom of a hill near a watercourse, where typically two thicknesses of pipe are tied, requiring technical welding skills.*
