Limited Mold Assessment Report

Texas Health and Human Services Commission

**Building 636
4110 Guadalupe Street
Austin, Texas 78751**

Reference: LIMITED MOLD ASSESSMENT REPORT
Texas Health and Human Services Commission
Building 636
4110 Guadalupe Street
Austin, Texas 78751
Baer Engineering Document No. 181006-8i.060

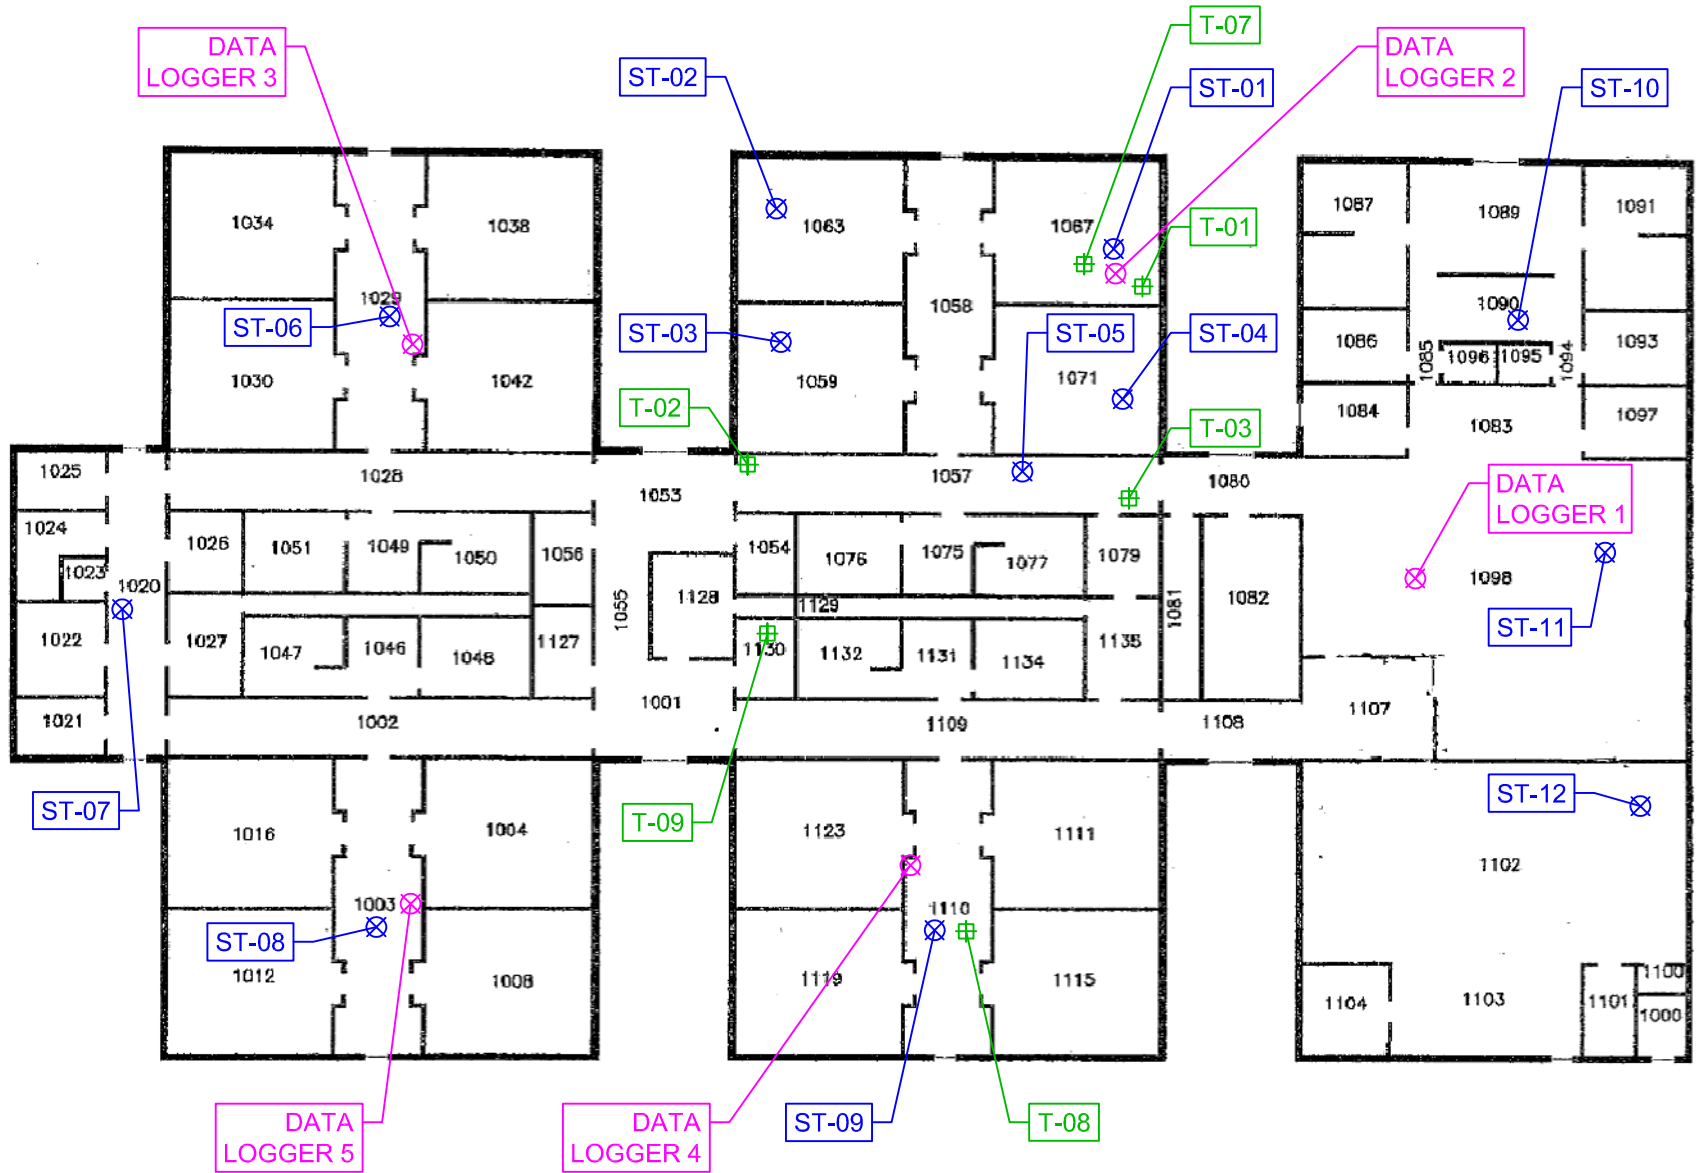
**Figure 2.1 - Mold Sample Locations -
Building 636**

Section 2, Table 2.2 provides a summary of the fungal types and relative amounts identified in the direct contact samples. The sample locations are indicated in Section 2, Figure 2.1.

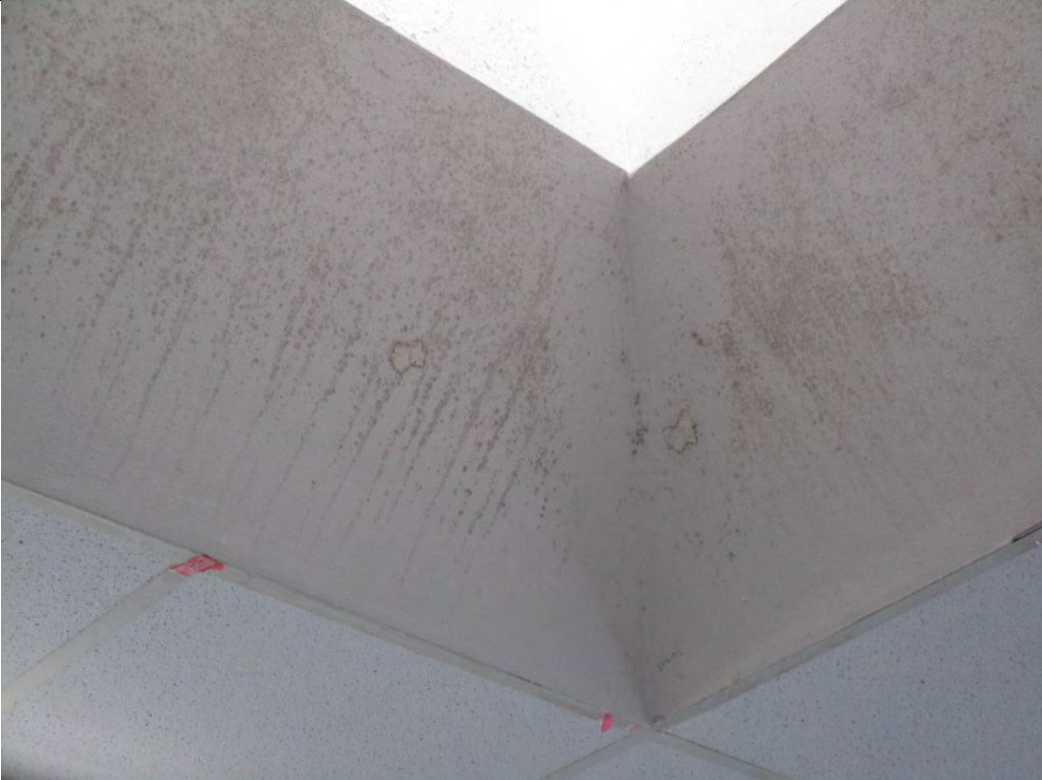
<p data-bbox="1281 520 1403 552">Photo #3</p> <p data-bbox="1206 588 1477 653">Visible Suspect Mold around Skylight</p>

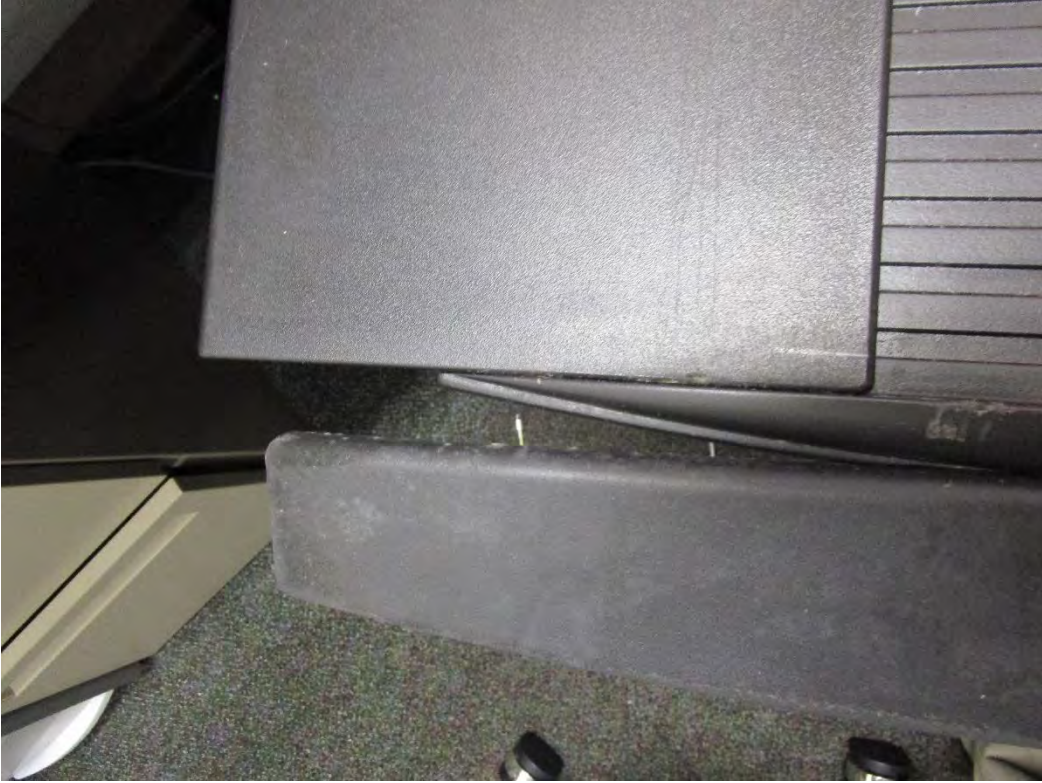
<p data-bbox="1284 1302 1399 1333">Photo #4</p> <p data-bbox="1187 1369 1497 1434">Visible Suspect Mold on Desk</p>

1. All furniture (chairs, desks, etc.) that have been contaminated by mold, or affected by water intrusion, should be professionally cleaned, or if they cannot be cleaned, they should be disposed of.
2. The damaged drywall walls in Quads 1058, 1003, and 1110 should be removed and replaced with new material.
3. The HVAC cycling at nights and weekends is causing temperature and humidity issues that promote mold growth. Relative humidity levels should be kept at, or below 65%, or the temperature should be kept at, or below, 82 degrees Fahrenheit.
4. The HVAC system should be evaluated by a professional HVAC contractor to determine if it is operating correctly. Elevated CO₂ levels indicate that there may be a performance issue related to the HVAC system.

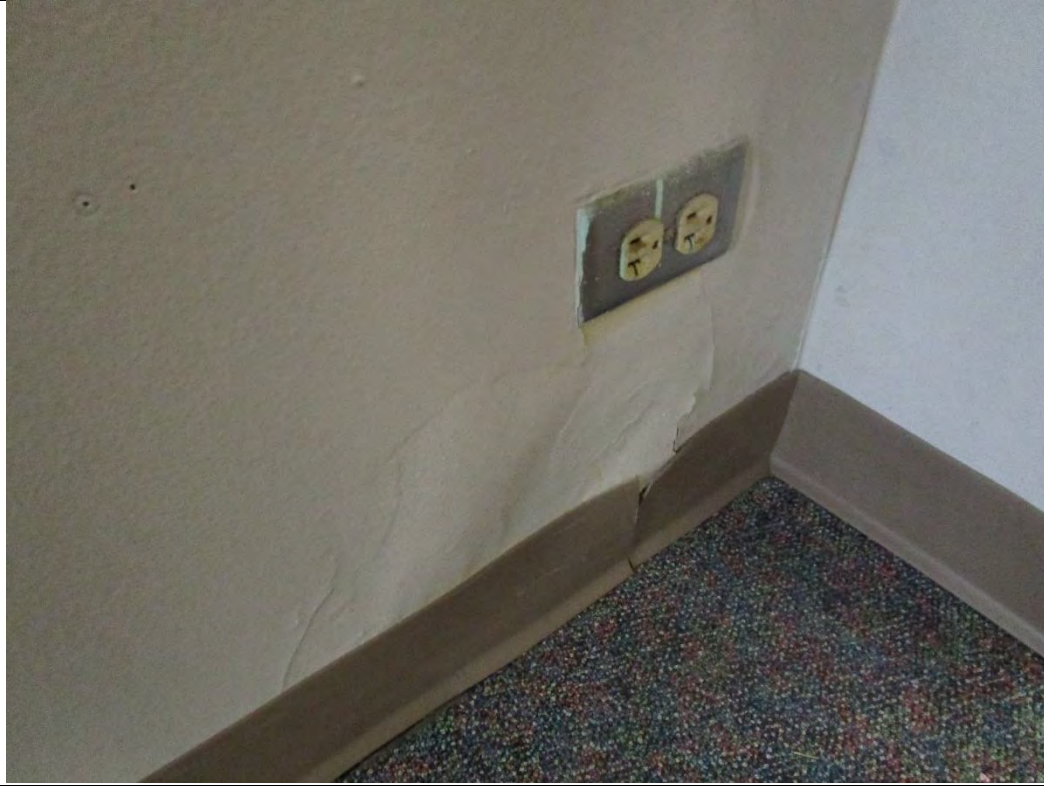
Photo #5

visible indications of the suspect mold. The building personnel also stated that previous water intrusions had occurred and seemed to only affect the lower portion of the walls of the building. Mr. Steeghs noticed a musty odor in Quad 1058 and investigated the space above the ceiling in the areas, including the ceiling tile system, drywall walls, and roof drain areas. However, the only visible indication of water intrusion observed was water-impacted drywall of the lower interior walls in Quads 1058, 1003, and 1110.

Visible Water Impacted
Drywall
